State University of New York at Fredonia

FACILITIES MASTER PLAN
CAPITAL PLAN YEARS 2013-2023
Phase Two : Assessment of Conditions

FINAL PROOF SET
MAY 9, 2011

Project No: 05823

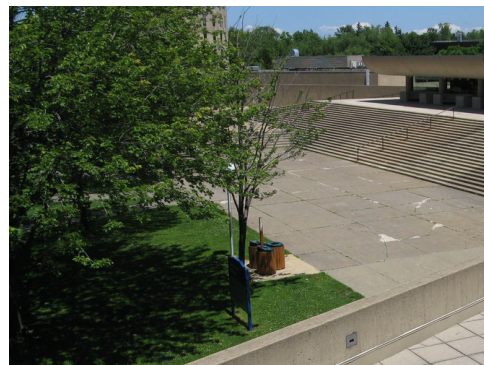
Library steps and Plaza as seen from the Spine. The vast plaza paving is in need of repair or redesign.

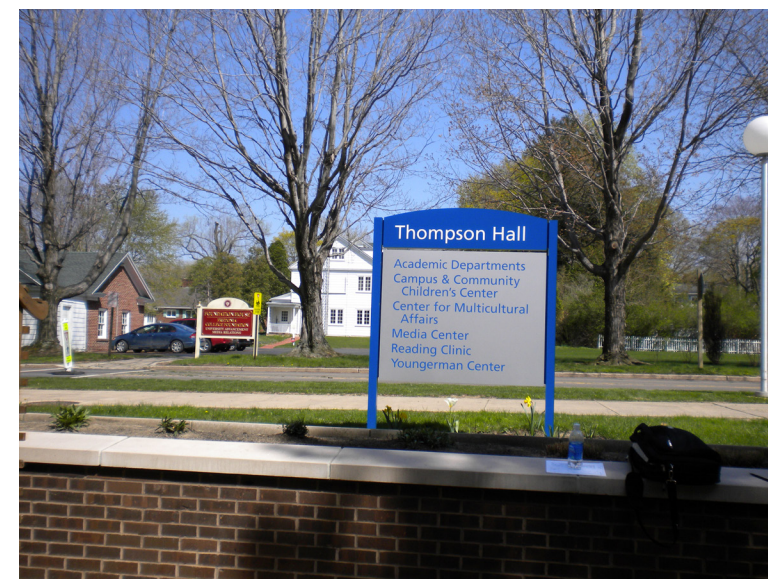
New campus building signage is sometimes oriented facing building entrances or away from major pedestrian and vehicular routes, rendering it ineffective for wayfinding.

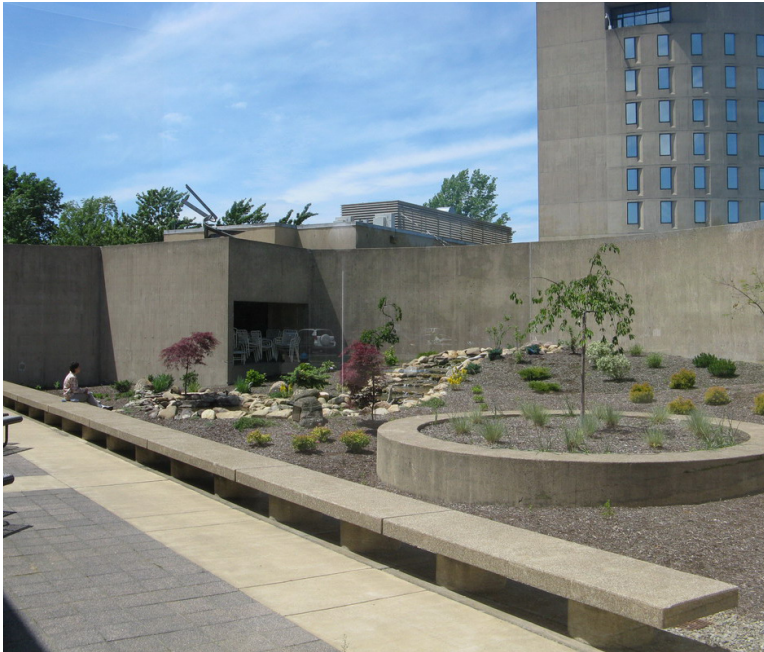
The Japanese Garden at Reed Library has a water cascade and miniature plantings. The planting palette does not provide sufficient shade in this "hot spot".

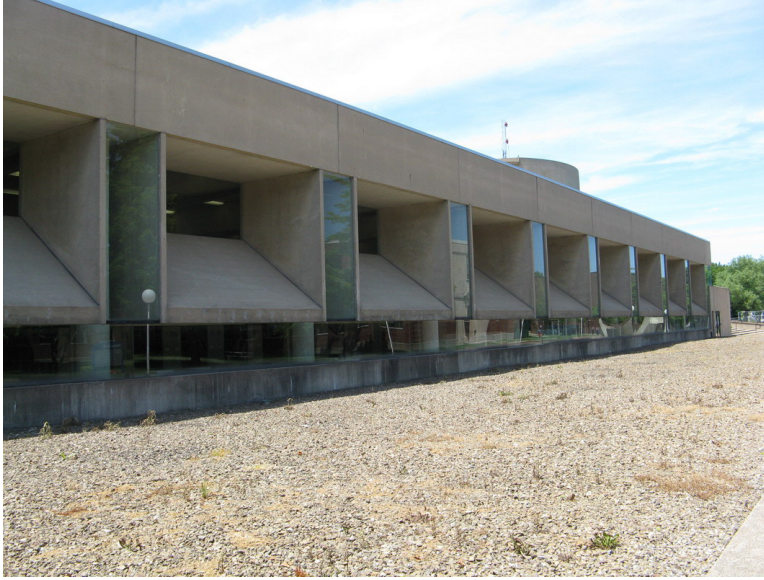
The Library would benefit from a green foreground instead of the present gravel bed.

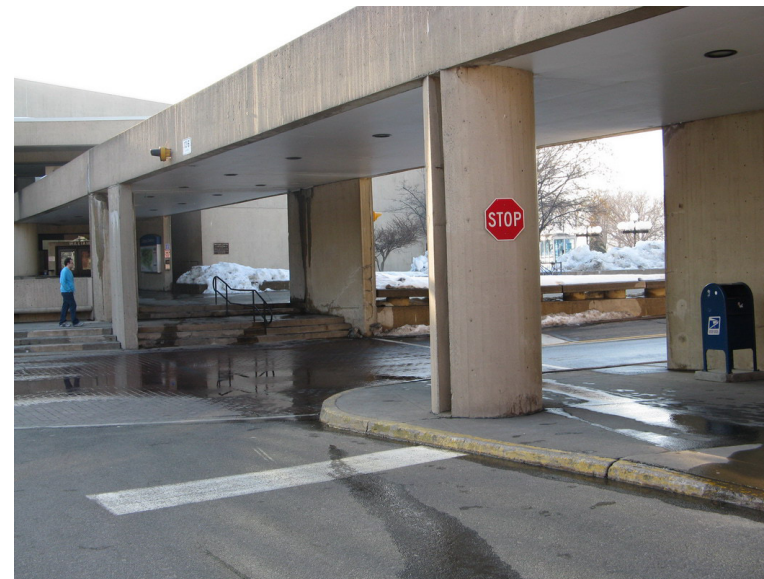
The crosswalk and Williams Center entrance lack direct accessibility from the Spine walkway.

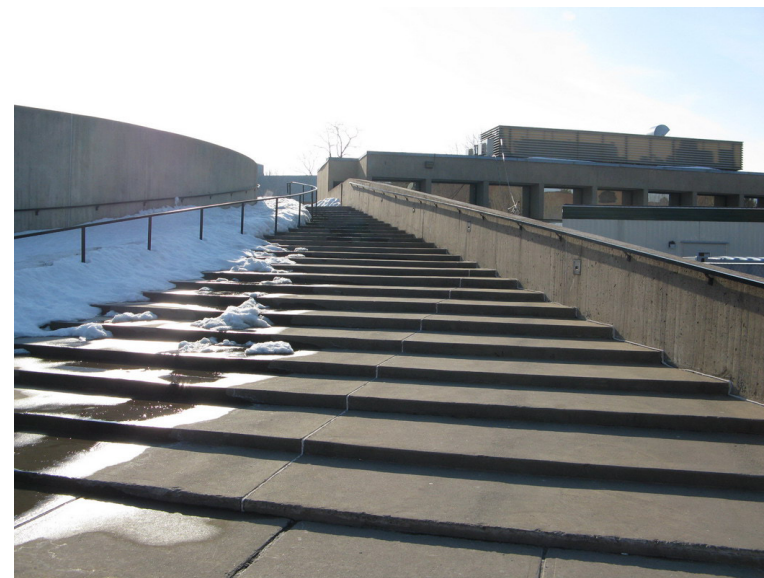
Long flights of stairs at the Library are a barrier to universal site accessibility. An alternate path exists, but it is not well marked.

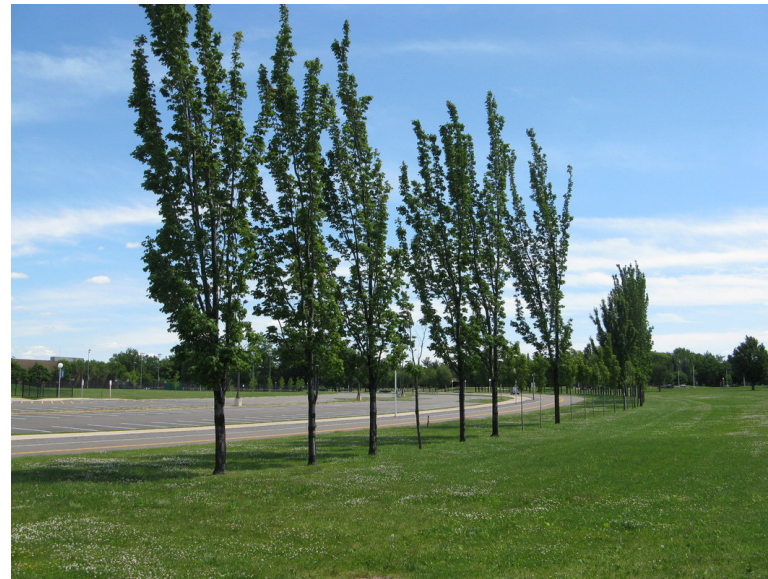
Trees along the Ring Road have suffered from strong westerly winds; many replacement have been made over the years and the uniformity of planting has been lost.

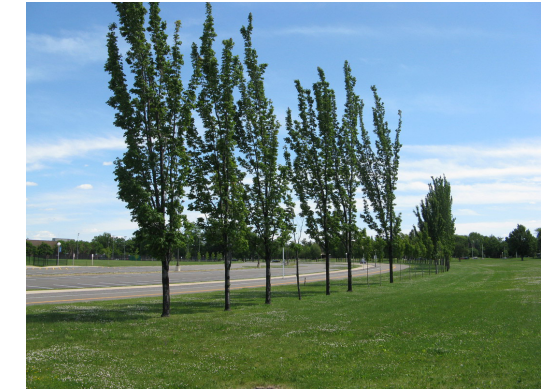
14. The Armstrong Maples along the ring road have had many replacements due to their damage from wind. The new plantings are 2" caliper saplings, which will take years to catch up in size to the existing older maples. The visual continuity of a "green colonnade" has been lost.

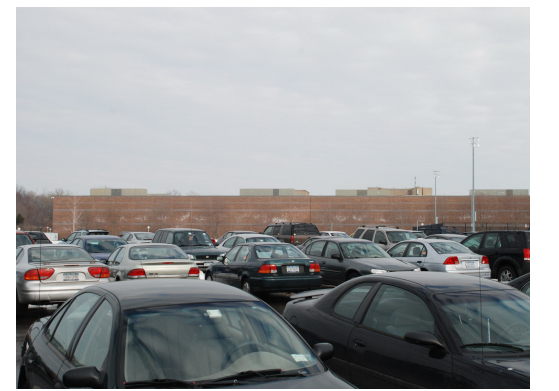
15. View from Ring Road over the parking lot towards Steele Hall. The long windowless façade creates a severe edge in winter, when the deciduous trees in front of have lost their foliage.
