State University of New York at Fredonia

FACILITIES MASTER PLAN
CAPITAL PLAN YEARS 2013-2023
Phase Two : Assessment of Conditions

FINAL PROOF SET
MAY 9, 2011

Project No: 05823

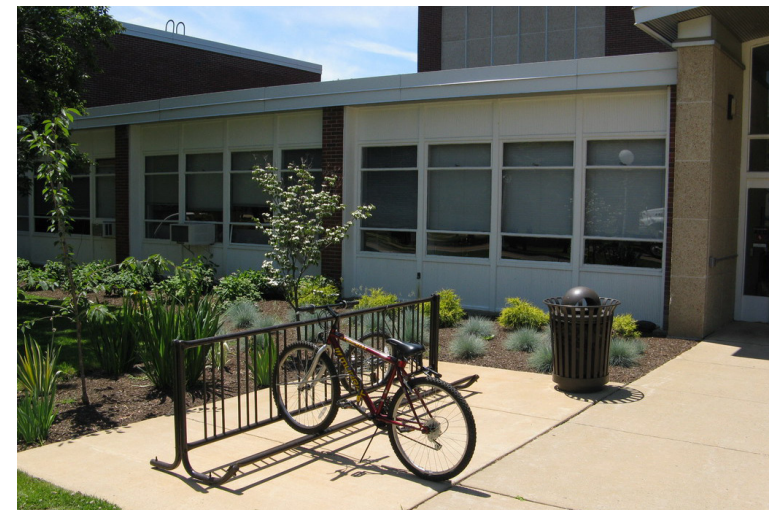
The stepped plazas in the Academic Quad are an obstacle to most bicyclists.

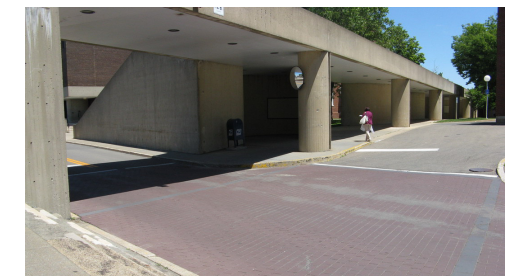
The intersection of the Spine and Old Main Drive is a blind spot and a major circulation conflict point.

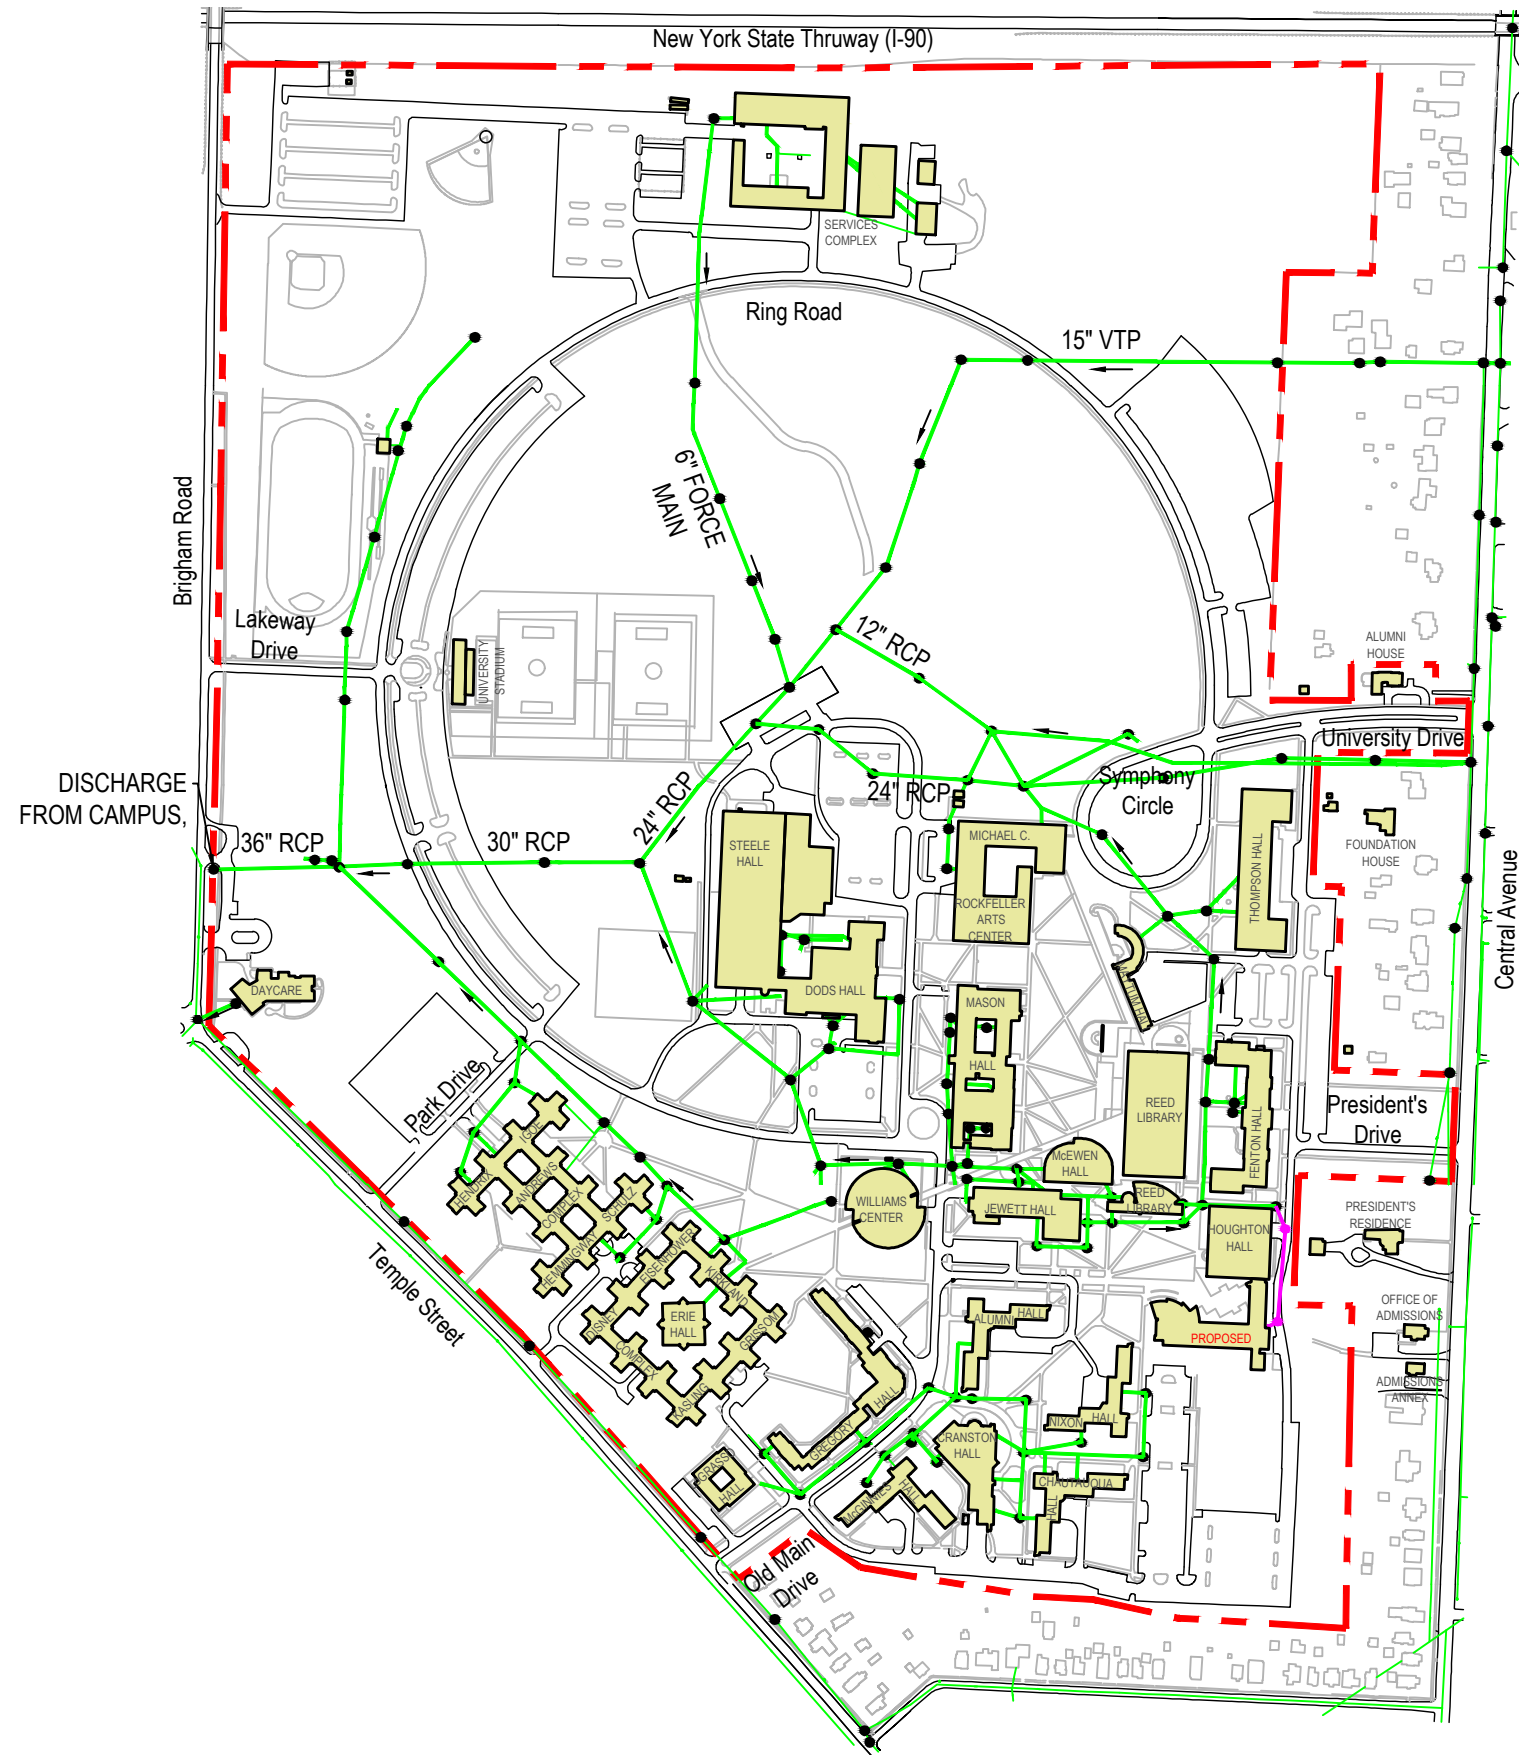
Maintenance on the campus sewer system is performed as required. Tree root penetration at the older sections of pipe has been a common backup problem. Grease build-up from the University dining facilities found in Erie Hall, Williams Center and University Commons have created blockage issues. Some manholes and pipes in these prone areas are flushed as time permits.

- Perform a closed circuit video (CCTV) inspection of the sanitary sewer lines campus wide to determine conditions and potential problem areas. CCTV will also aid in the identification of correct structure networking.
- Perform regular maintenance on sanitary lines and manholes.
- Phase replacement construction of original brick manhole structures.

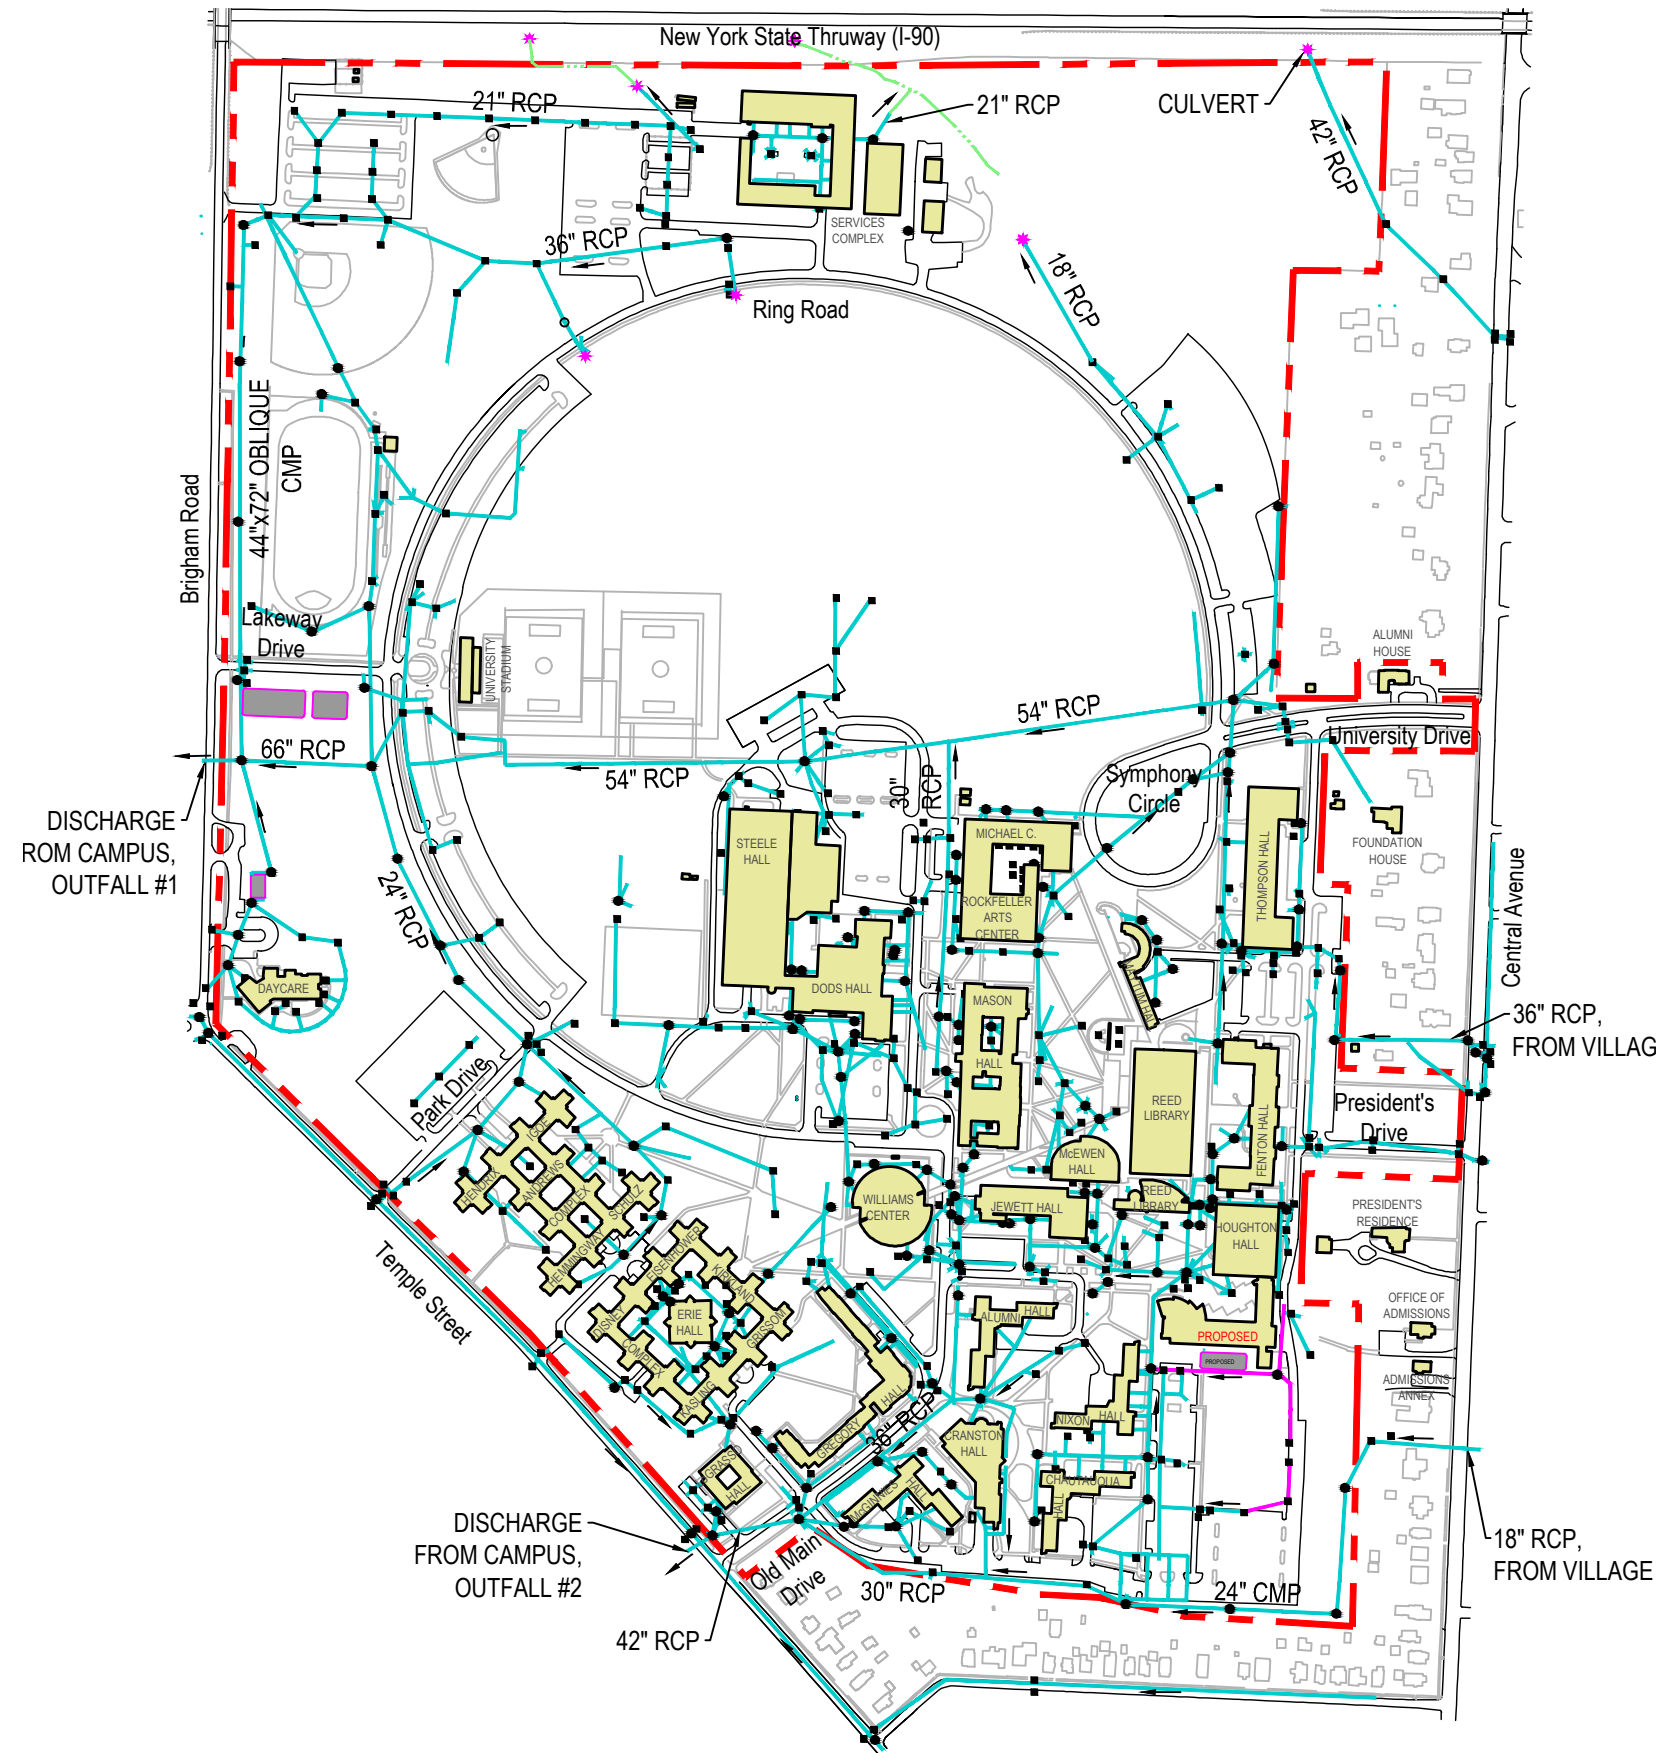
There are two storm sewer trunks from the campus on the west side which discharge into Canadaway Creek. Both trunks transfer stormwater collected by the Village of Fredonia's storm water system through the campus. Based on analysis of the storm system done under the Stormwater Master Plan (2008), the 42" diameter (Outfall #2) southwest discharge rate for a 10-year rainfall event is equivalent to the outlet pipe capacity under existing conditions. Localized backups and flooding may occur with collection of additional stormwater into this system as the campus expands.

The campus currently performs maintenance on sections of the storm sewer system when possible. Pipes are flushed, and structure sumps cleared of debris accumulation as time permits during the summer months. Structures are replaced by the facility staff on an as-needed basis when outside the scope of ongoing construction projects.

- Perform a closed circuit video (CCTV) inspection of the storm sewer lines campus wide to determine conditions and potential problem areas. CCTV will also aid in the identification of drains and structures for developing system mapping.
- Continue regular maintenance on storm lines, manholes and catch basins.
- Establish a campus inspection schedule of storm system.

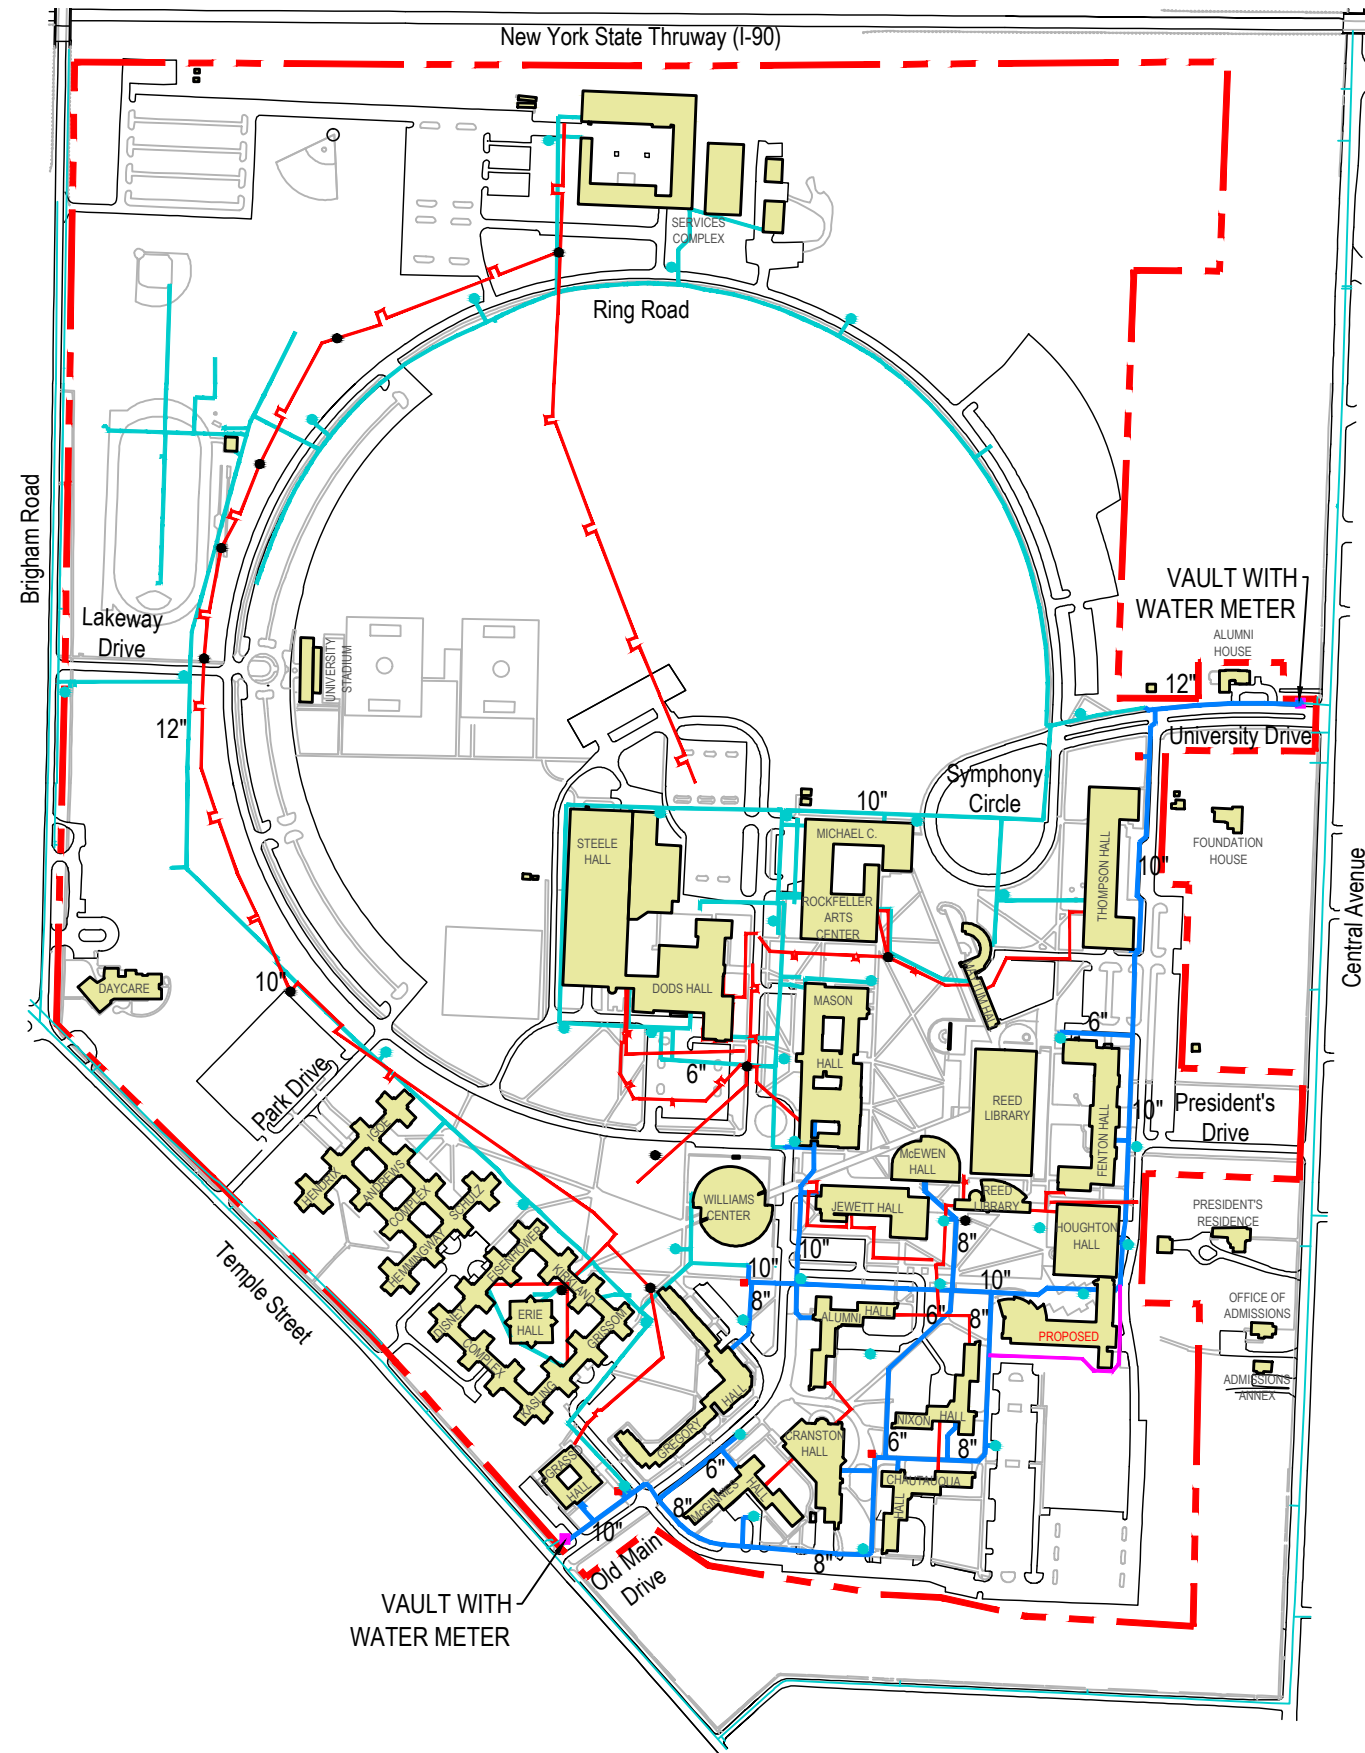
As seen on the Water Distribution Map, the 2000 water replacement work was limited to the southeast quadrant of the campus. This project replaced the water mains between both water meter vaults along Academic Avenue and Science Drive. Laterals to existing buildings and fire hydrants found along the replacement alignment were replaced as encountered. Valves and pipe stubs have been installed at various locations to provide for future water line replacement project connections. Phase II of the replacement is in design and is slated to begin construction Spring of 2011. The scope of work for this project includes 8,000 linear feet of underground water line and 15 fire hydrants.

The campus has identified that water line problems or breaks have been relatively infrequent. Based on the BCAS assessment report this system has been rated 25% Poor, 25% Fair and 50% Good. Any waterlines older than 50 years should be considered near the end of their useful design life and considered for replacement.

- Installation of water meters at each building, allowing for detailed usage review.
- Replacement of original underground water mains not included in Phase II project (+3,000lf).
- Continue with regular maintenance on hydrants and valves, including flushing hydrants and opening and closing valves.

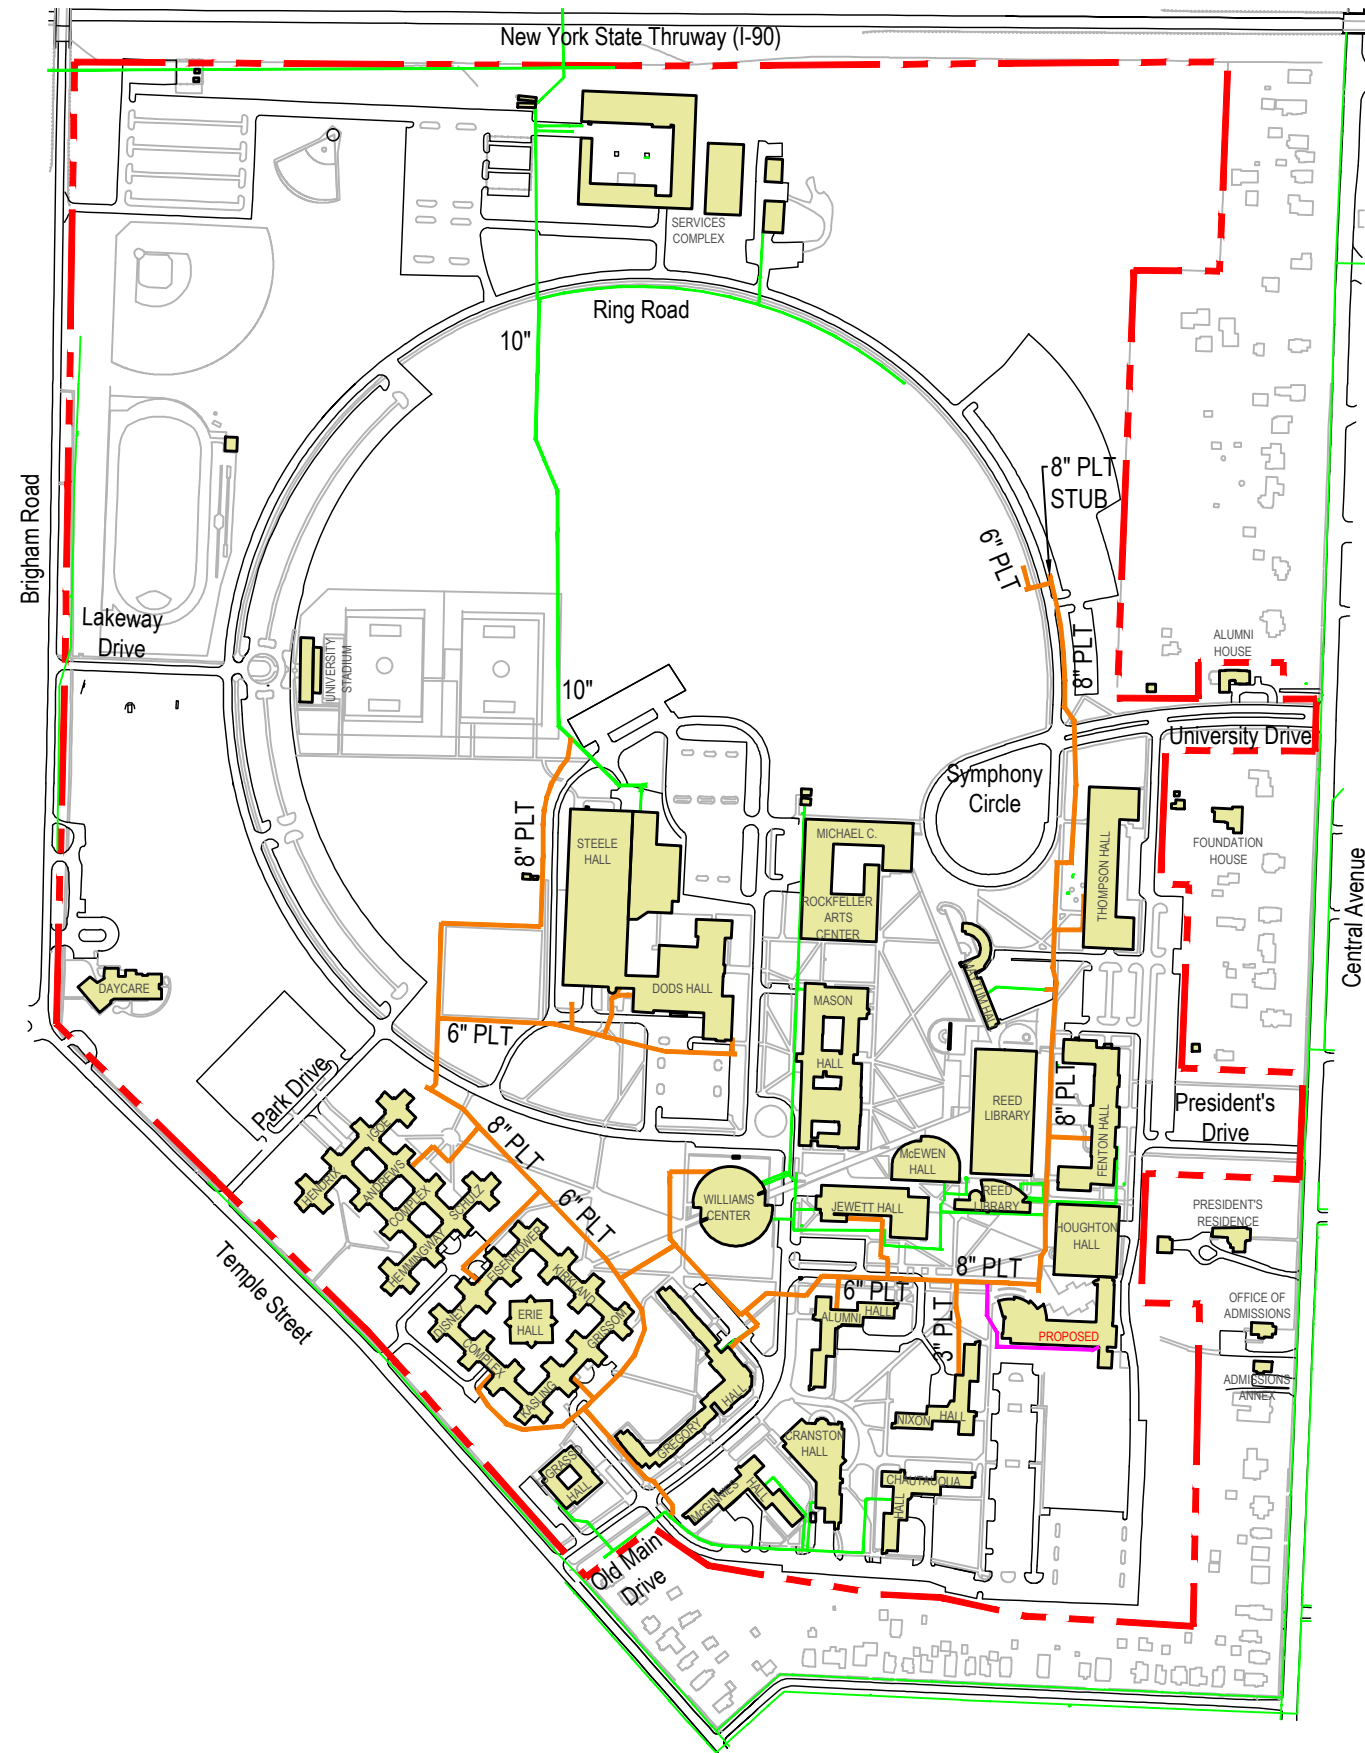
In 2007 a campus wide gas upgrade project replaced the majority of existing gas piping with plastic pipe. Natural gas is piped over the campus as shown on the Gas Distribution Map, with differentiation between 2007 work and existing piping. The gas lines on the campus are owned and maintained by SUNY Fredonia. National Fuel provides gas to the campus from a gas main along the New York State Thruway, which ties in at the Services Complex. From the Services Complex a ten inch (10") line runs south through the Ring Road to Steele Hall. At this location the service is reduced to eight inch (8") pipe which branches as shown on the Gas Distribution Map to the facility buildings. Generally the gas lines within the campus consist of six (6") and eight inches (8") lines.

- Replacement of original gas lines not included in 2007 project.
- Update mapping of campus utilities, identifying active and abandoned lines/valves.

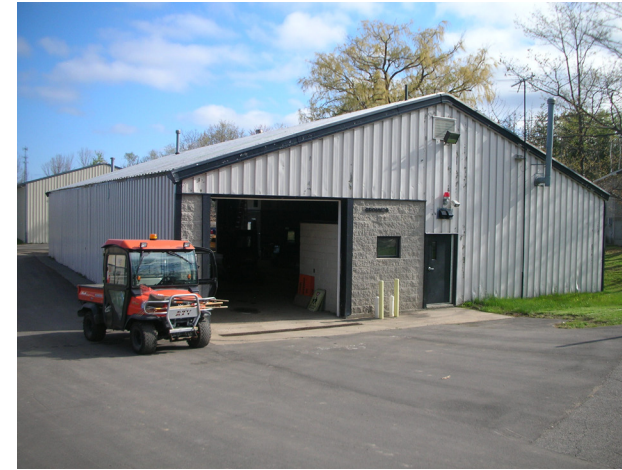
Butler Building (Building No. 60)

The exterior of the Butler Building is corrugated aluminum with a small wall of split-face concrete block at the front entrance. The roof is also corrugated aluminum, with fiberglass acrylic panels for skylights. The corrugated walls are in fair to poor condition, with paint finish deteriorating and numerous minor dents around the building perimeter. Man doors and rolling doors at each end of the building are in fair condition.

The Butler Building is an open shed inside with an exposed pre-manufactured steel frame and concrete floor. The walls and roof of the interior are insulated. The insulation is generally in good condition, though the plastic facing is deteriorated in several locations. The floor is in good condition with a central trench drain down the middle.

The building MEP systems are in good condition.

- Door Comment: Exterior doors and door finish at original building deteriorating due to weathering.

- Stair Comment: Rubber treads and landing tiles exhibiting wear.

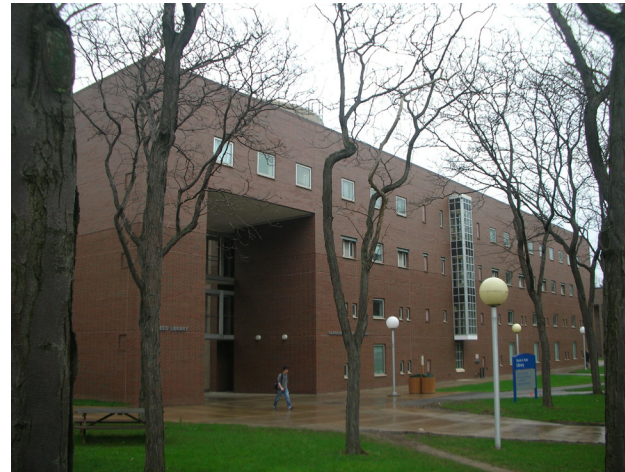
Carnahan Jackson Center - Addition to Reed Library (Building No. 12a)

The Carnahan Jackson Center is constructed of dark brown brick similar to Houghton Hall to its east. At its north side, facing McEwen Hall and Reed Library, is a concrete block cylinder with a large skylight at the roof. The exterior envelope of Carnahan Jackson is in good condition. Windows, doors and masonry have all weathered well. The roof, while reaching 20 years old, has not had any problems.

Carnahan Jackson's interior is generally in good condition. A small atrium space at the connection to Reed Library provides a light-filled transition to the building and employs exposed cast concrete structure in a nod to the Pei-era buildings. An open stairway in the atrium gives access to the various stack levels and Writing Center. Interior finishes are mostly brick, cast concrete and carpeting and have been highly durable.

The MEP Systems for the building are generally in good condition. The Chiller is at the end of its useful life and is oversized for the load. The building needs a new fire alarm system upgrade.

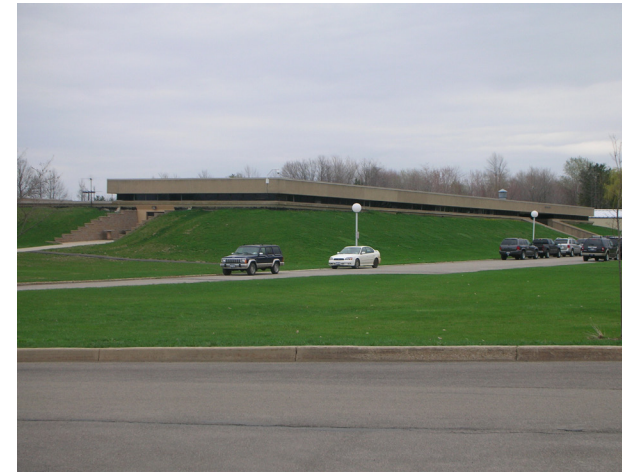
Central Heating Plant (Building No. 27)

The Central Heating Plant has been the subject of major asbestos abatement work over the last 10 years. The vast majority of asbestos pipe and tank insulation removed inside the facility in and abatement project this year. The original boilers were abated and demolished as part of this project. There is some asbestos cloth wrap on fiberglass insulated pipe and mudded fittings that remain in the far west portion of the building.

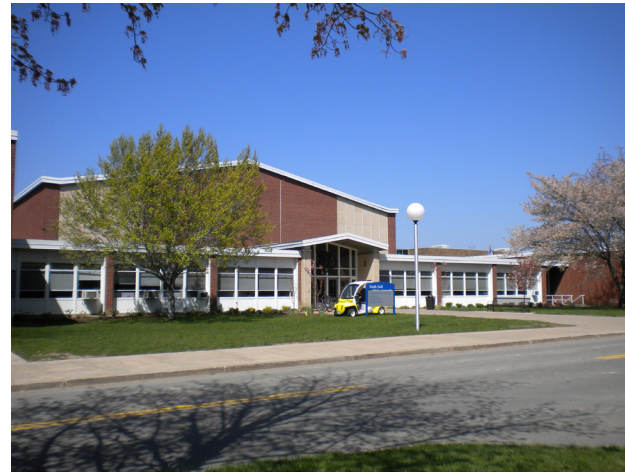
Dods Hall
(Building No. 16)

Dods Hall is a steel-frame building with red brick and aggregate concrete panels for exterior walls. The aggregate panels are aged and wearing and the brick is in need of general maintenance. Dods Hall's steel windows are original to the building and showing signs of wear and deterioration, particularly at the front entrance. The roof is in fair condition, but reaching the end of its expected life.

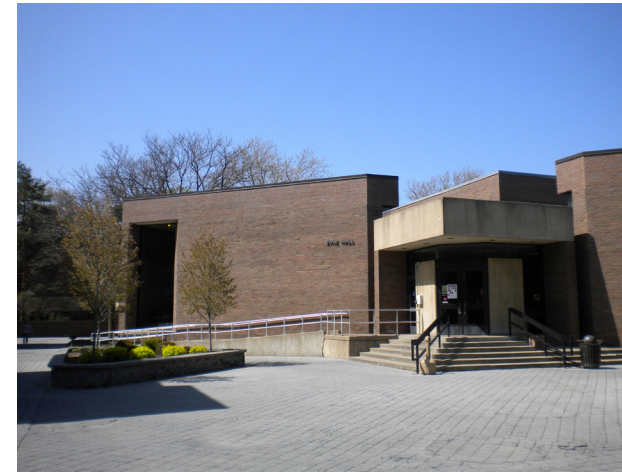
Erie Hall Dining (Building No. 23)

This building has recently undergone extensive renovations that resulted in the abatement of most of the asbestos-containing flooring and much of the asbestos-containing thermal system insulation. Records indicate that there is still asbestos-containing pipe and fitting insulation in the basement. Asbestos-containing gaskets have also been identified.

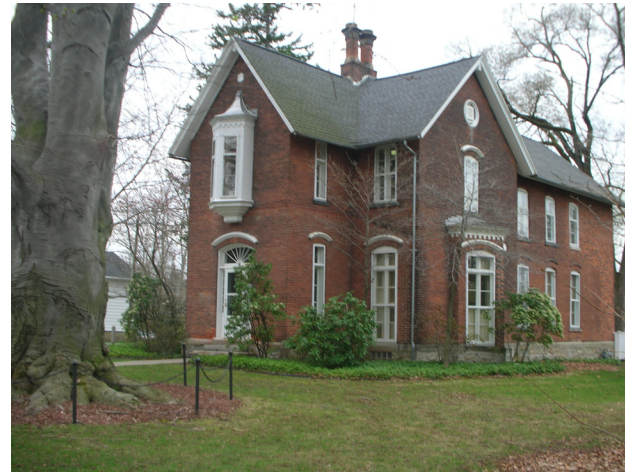
Fenner House
(Building No. 57)

The exterior of Fenner House is load-bearing red brick with wood detailing at the roof, cornice, doors and windows. A wood porch is located to the south of the building at the first floor. Generally, the exterior of the building is in fair condition, though the mortar in the masonry requires significant re-pointing, especially in areas around the original front door and second floor oriel window. Windows and doors are weathered and worn. The wood frame of Fenner House has several structural deficiencies. These are outlined in the appendix at the end of this document.

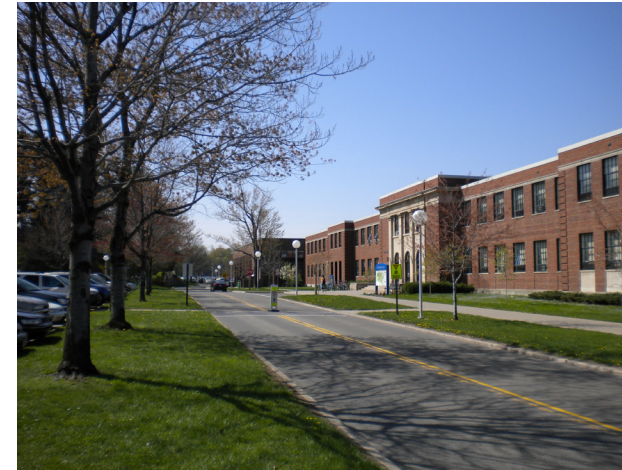
**Fenton Hall
(Building No. 1)**

There is asbestos-containing floor tile and mastic throughout the building. There is also asbestos-containing pipe and fitting insulation likely concealed above ceilings and inside wall chases throughout the building. There is also asbestos sprayed on fireproofing (SOF) in this building.

Extensive abatement of pipe and tank insulation as well as SOF was recently completed in the mechanical rooms and tunnel as part of the Satellite Boiler project.

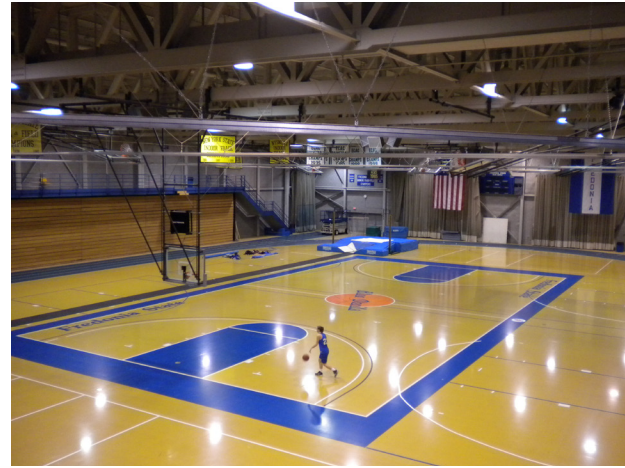
**Field House
(Building No. 62)**

Built with a dark brown brick cavity wall and absent any fenestration, the Field House's exterior dominates the view to the campus from the outer reaches of the Ring Road. The brick is generally in good condition, with small patches of efflorescence in a few locations on the long west façade. Doors are in good condition, but hardware has aged. The building's few windows are generally in fair condition, though some have occasional leaks. New aluminum coping and a new roof were installed in approximately 2008. Roof replacement is scheduled for 2011.

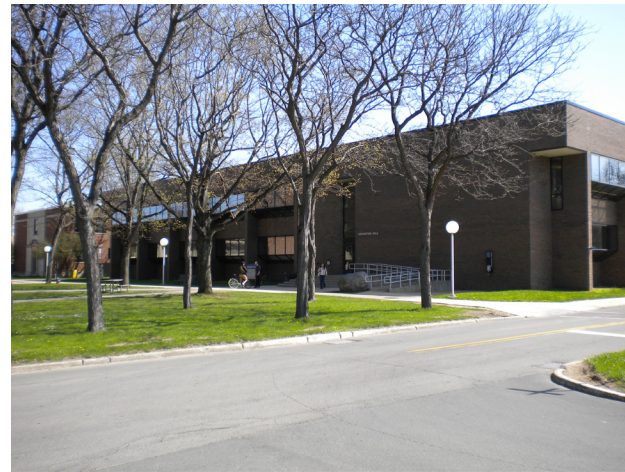
Houghton Hall (Building No. 15)

Built of dark brown brick, Houghton is the one academic building of Pei's master plan not made of cast concrete. Significant cracks in the brick at the four cantilevered corners of the building require repairs, and the cantilevered steel window bays have aged beyond their expected life. Staining and efflorescence is also noticeable beneath many of the window bays. Doors are also original to the building and in need of replacement. A new roof was installed in 1999.

- New roof in 1999
- Change exterior walls to 100% fair due to staining below window, efflorescence, and masonry cracks at building corners.

- Houghton Hall lacks flexibility and diversity of spaces such as computer rooms, lecture rooms, and other non-laboratory teaching spaces common to contemporary science facilities
- Building is in need of gut rehab, including window replacement, HVAC replacement, and asbestos abatement
- Not ADA accessible, and exits do not meet fire codes
- New Science and Technology building will address shortcomings of SUNY Fredonia's science facilities, and free up space for renovating Houghton

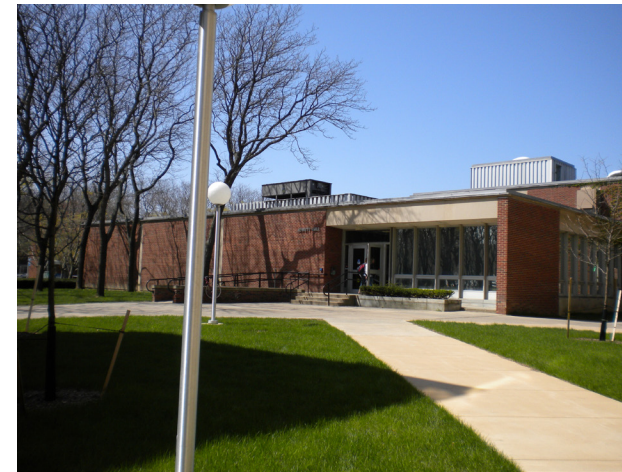
**Jewett Hall
(Building No. 14)**

The exterior of Jewett Hall is composed of a brick veneer wall with limestone spandrel panels and large aluminum windows. Given the age of the building, the exterior has weathered well, though minor damage to the stone and wear and efflorescence to the brick is apparent. Stone planters and steps at the front and side entrances of the building have severely deteriorated mortar joints. Windows are original to the building and in need of replacement.

The interior of Jewett Hall is generally in good to fair condition. Tile walls in the corridors have proven quite resilient, but the ceilings have deteriorated due to age, particularly at the entrance corridor. Terrazzo floors in the corridors are in fair condition, but lab floors have asbestos-containing and are in need of replacement. Doors and frames have also reached the point at which they need to be replaced due to age. There is a mid-sized tiered lecture room at the building's entrance that has recently had interior upgrades.

- Change ceilings to 25% poor due to deteriorated acoustic ceiling tiles at the building entry and

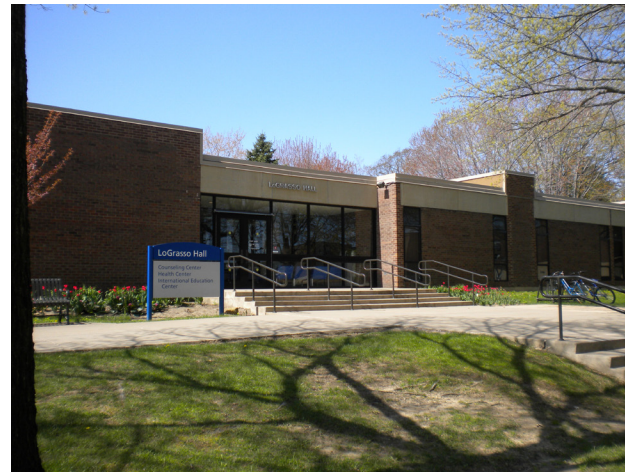
LoGrasso Hall's brick exterior wall is in poor condition, though its state is not readily apparent. Several years ago, remediation work to brick fin walls at the window openings revealed a severe deficiency in the number of masonry ties holding the brick veneer of the building in place. The shortage of brick ties means the veneer is insufficiently supported and will need to be replaced with a properly anchored wall system. Aside from the walls, windows are steel, original to the building and in need of replacement. Doors are aluminum, and while not original, also aging. The roof is in good condition, but coping from the roof installation is crudely detailed, probably the result of accommodating the removed fin walls at the windows.

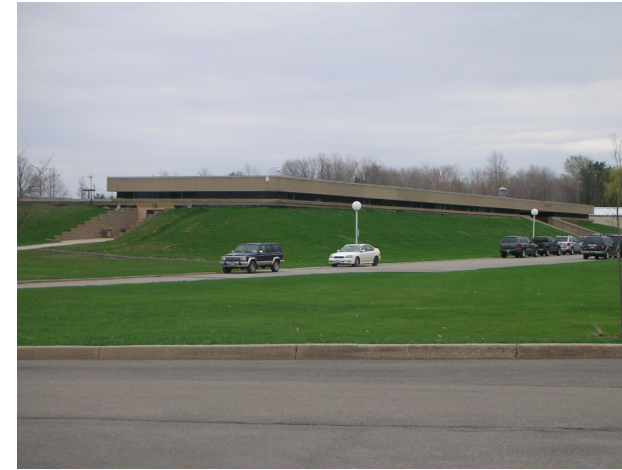
Maintenance Building
(Building No. 28)

The small amount of cast in place concrete that is visible above the earthen berms appears to be in good condition. Exterior walls in the courtyard are concrete block and in fair condition, showing some signs of age-related deterioration and weather-related staining. The exterior plaster soffit above the vehicular entrance is cracking and cast concrete stairs to the facilities maintenance office have been stabilized with wood framing. A relatively new membrane roof is in good condition. Windows and doors are original to the building and in poor condition.

The interior of the Maintenance Building is in fair condition. The finishes are typical for basic office construction: acoustic ceiling tiles, drywall office partitions and commercial carpeting. The building is not accessible at its front entrance.

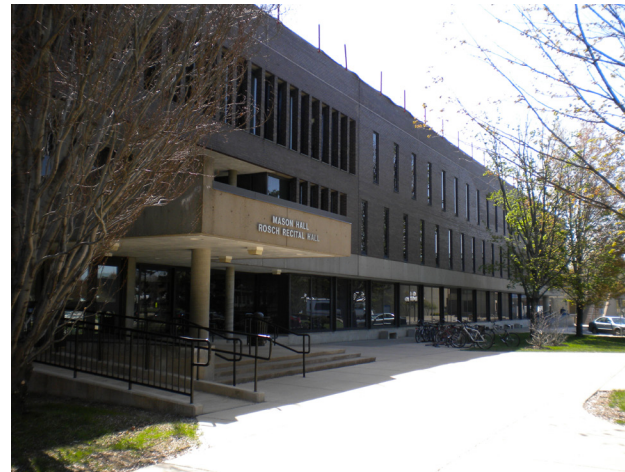
**Mason Hall Addition
(Building No. 2b)**

The Mason Hall Addition has an exterior enclosure of dark brown brick with series of narrow window openings on the upper stories and larger expanses of glazing on the ground floor. Windows are aluminum and thermally glazed, with slate sills that are in good condition. The main entrance doors were replaced in 2010 and the roof was replaced early 2010. Two separate courtyards exist in the residual spaces created where the Addition meets the original Mason Hall.

The interior of the Mason Addition is generally in poor to fair condition. Wall finishes are aging, slate stair treads are beginning to show wear and the elevator, which is original to the building, is in need of an upgrade. Flooring on the upper levels is in good condition, but at the ground level, unevenness in the slate flooring causes problems for pedestrian traffic and instruments that are wheeled over its surface. Ongoing above-ceiling work in portions of the corridors has enabled the College to install new ACT in these areas.

The MEP Systems for the building are basically in fair condition. The systems are nearing the end of their useful life. The HVAC air handling units, duct distribution and reheat coils need extensive upgrades. The fire alarm system needs to be replaced.

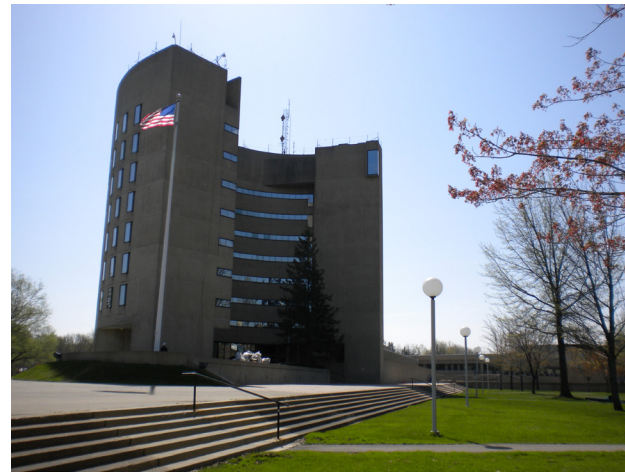
Maytum Hall is constructed of cast-in-place buff-colored concrete with the structural walls also serving as the exterior envelope of the building. The condition of the concrete is varied. On the walls interior to the crescent, there are numerous cracks which have been sealed with silicone caulking. While addressing potential water infiltration issues, the sealant has created an unsightly appearance. Minor cracking also appears in some locations at the building's foundation. Maytum's windows were replaced in 1998 and were caulked in 2008 to correct leaking issues. Various windows still occasionally leak depending on the severity of the rainfall and wind. The roof was also replaced around 2008 and is also in very good condition.

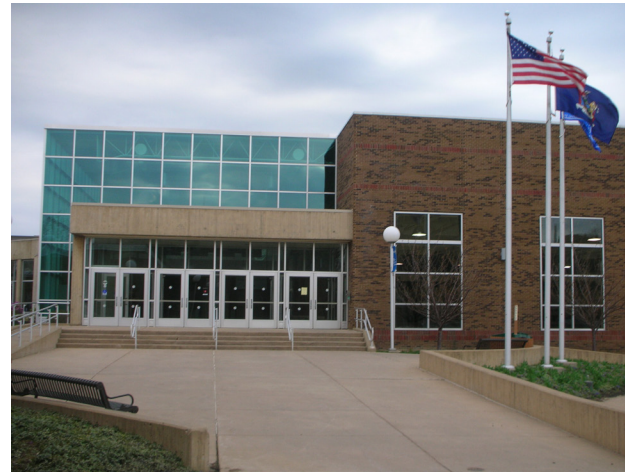
The Steele Hall Natatorium's exterior is in excellent condition consistent with its age. The brown brick veneer contrasts with the red brick of Dod's Hall, but is consistent with the other modernist brick buildings on campus. Minor water infiltration at the east foundation has persisted since construction was completed. Remedial work to stop the leaking has been ongoing.

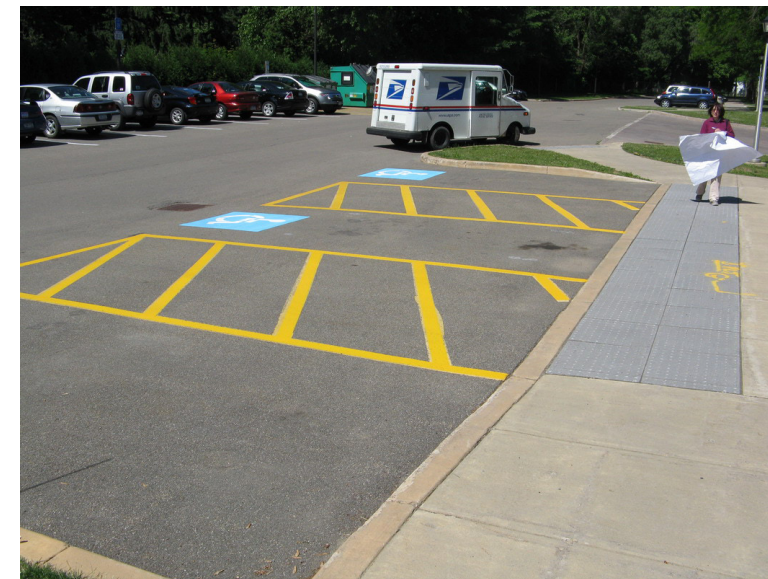
The crosswalk and Williams Center entrance lack direct accessibility from the Spine walkway.

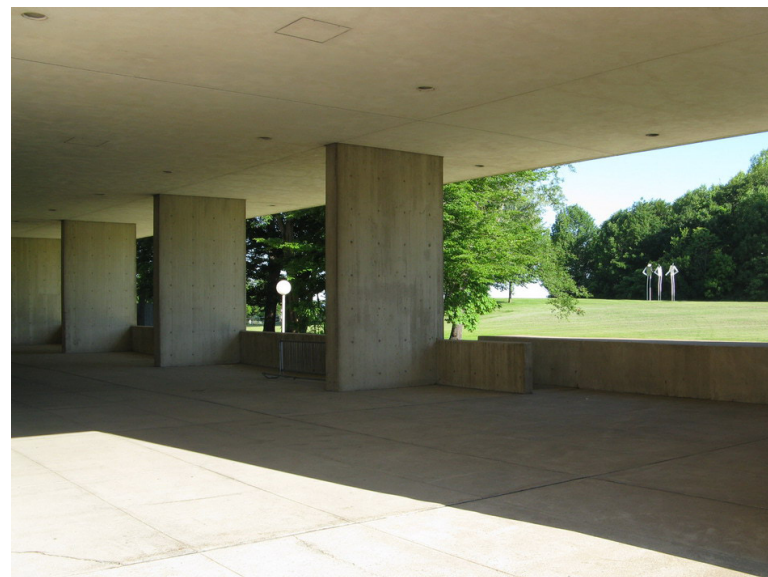
Sharp transitions from dense shade to bright light could be difficult on the eye. At the Rockefeller Center colonnade, the deep building shadow helps bring out the framed vista beyond.

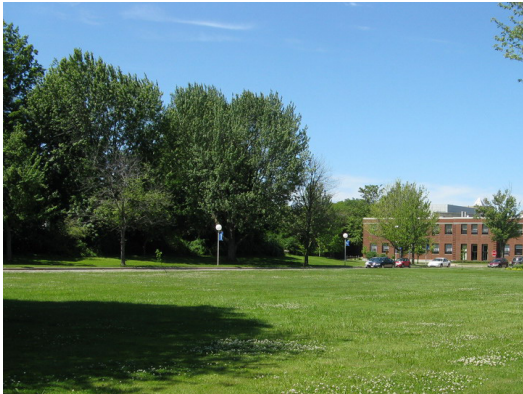
2. The formal lawn with the flag and brick college building as the focal point present a traditional institutional image. There are no signs to identify the college.

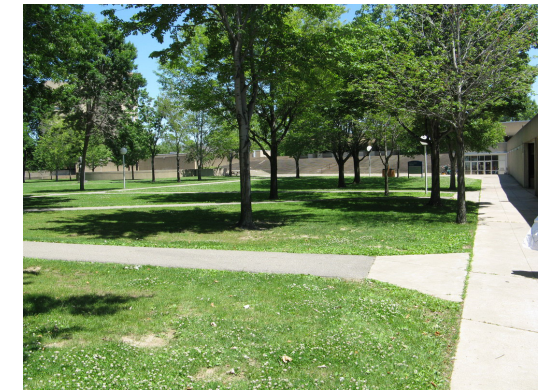
4d. The Academic Quad appears tired with its mature trees, bituminous paths, and lack of amenities.

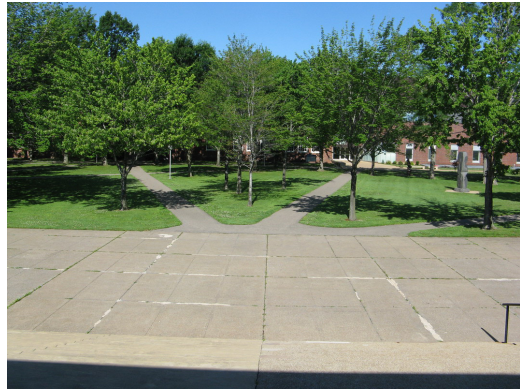
5. The Academic Quad as seen from the Library terrace. The plaza and the Quad would benefit from design improvements.

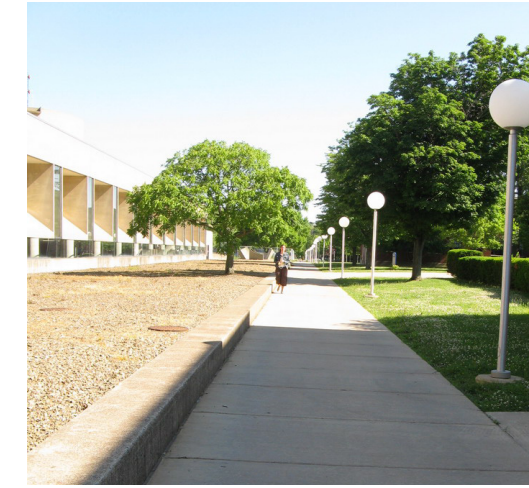
12. The strong linear form of the promenade, which extends from Houghton Hall along Fenton and Thompson Hall to Symphony Circle, is reinforced by the row of pedestrian luminaires and the long seat wall. The gravel bed to the left presents an opportunity to create an attractive green landscape, which would enrich this environment and provide a better setting for Reed Library.
